NACA RM E53K27

EXPLORATORY ENGINE TEST OF TRANSPIRATION-COOLED TURBINE-ROTOR BLADE WITH WIRE-CLOTH SHELL

By Patrick L. Donoughe and Anthony J. Diaguila

January 20, 1954
Declassified December 3, 1958

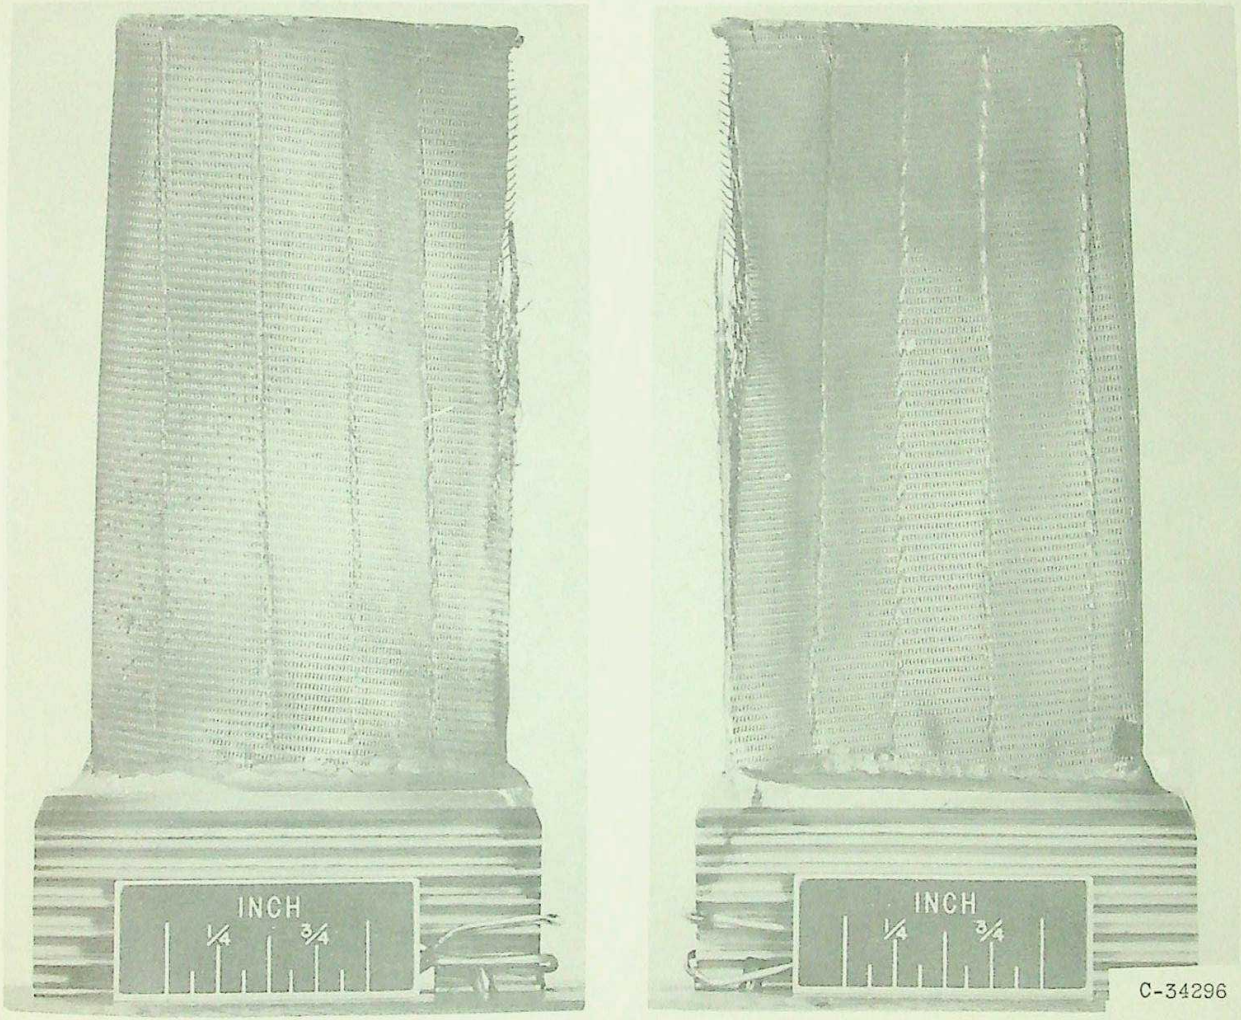
Visual inspection of the transpiration-cooled blades after engine operation at 11,500 rpm and an effective gas temperature of 1350° F showed that part of the wire cloth on the trailing edge of the tip region had been severed from the rest of the blade (fig. 8). When metal discoloration was used as an indication of maximum operating temperature, the wire-cloth shell did not appear greatly overheated in other regions. The pressure surfaces of both shells were hotter than the suction surfaces, as may be noted by the discoloration patterns shown in figures 8(b) and 9(b). Somewhat higher temperatures at the junction of the wire cloth and the strut than in the porous regions were also indicated. No evidence was apparent, however, of any separation in the band between the shell and the fins on the strut.

The damage in the trailing-edge region was probably due to the fabrication methods. It is possible that the welding necessary to join the wire cloth may have induced brittleness in the wires in the neighborhood of the weld, so that some caution should be exercised in design and fabrication of this region. Perhaps the lack of sufficient rigidity could be alleviated by a shorter span from the strut support to the trailing edge of the shell.

Figure 8. - Blade 1 after subjection to engine test.

4. Consideration should be given to strengthening the trailing-edge section of the blade where the shell was damaged during the high-speed engine test.

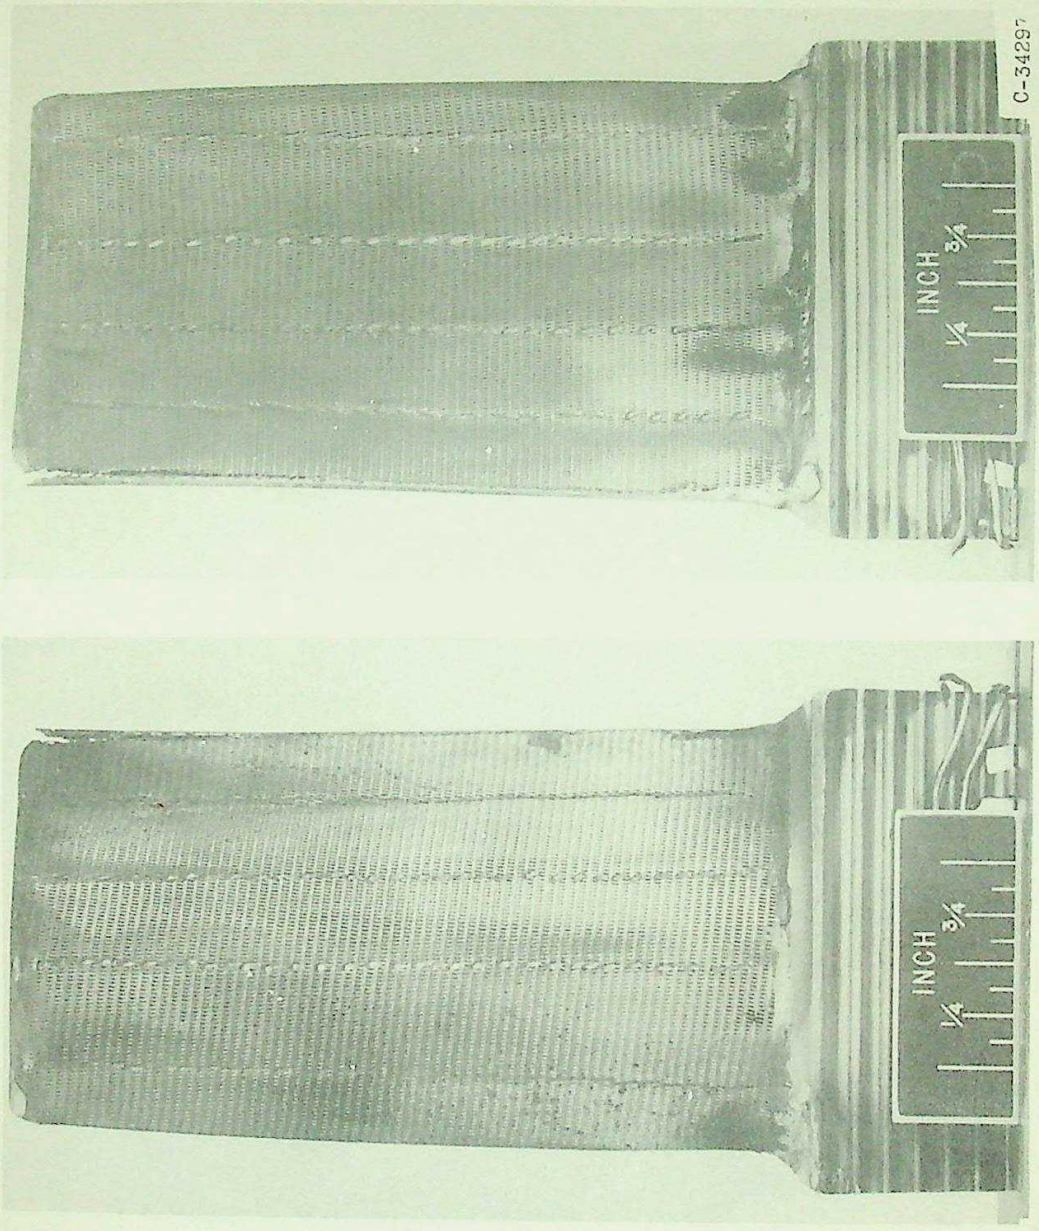
Although there are definite indications of spanwise variations in shell temperature, the orifices in the base of the strut seemed to provide satisfactory coolant distribution to minimize chordwise temperature variations (figs. 7(a), 8(a), and 9(a)).

Figure 9. - Blade 2 after subjection to engine test.
